Ida Lake

(Douglas County)

Curlyleaf Pondweed Delineation

Survey Date: May 26, 2019

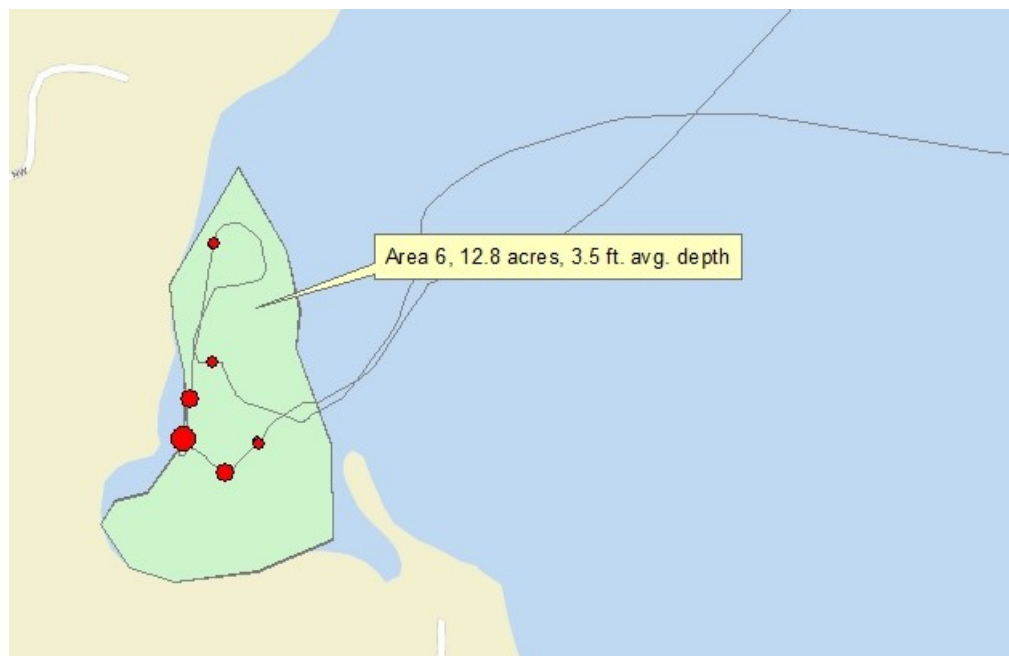
Area 6 - Recommend Treatment

CLP was abundant within treatment area 6 and is recommended for treatment in 2019.

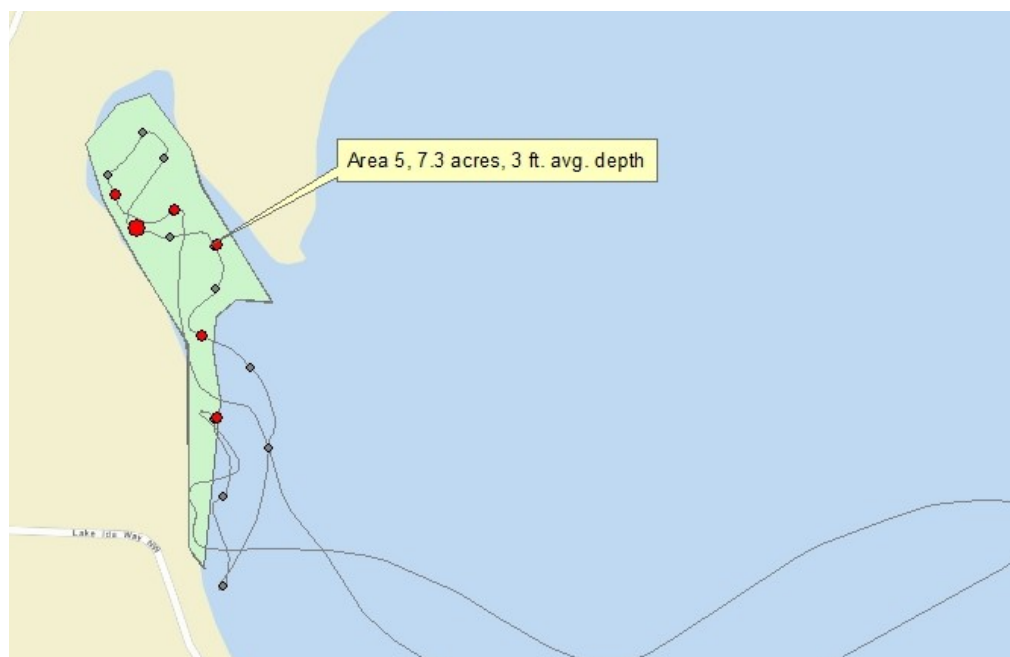
Area 5 - Recommend Treatment

CLP was found throughout treatment area 5 and is recommended for treatment in 2019.

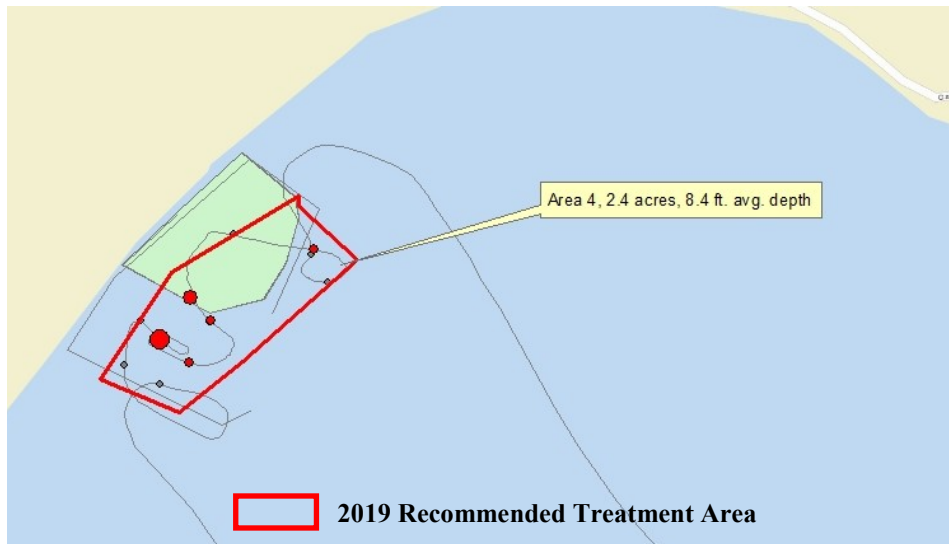
Area 4 - Recommend Treatment

CLP was found near treatment area 4 from 2018, however, we adjusted the site to better fit the distribution of CLP at this location. This site is recommended for treatment in 2019.

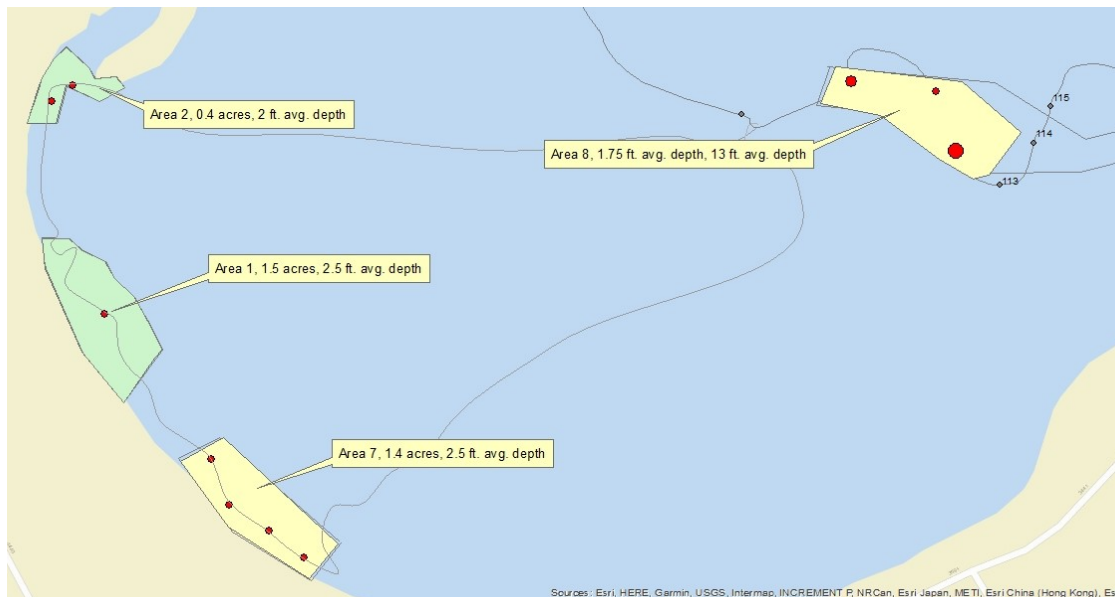
Areas 1 & 2—Recommend Treatment

CLP was observed in Areas 1 and 2, and are both recommended for treatment in 2019.

Area 7 was not treated in 2018, but CLP was observed here during the 2018 CLP survey and was again observed during the 2019 CLP survey. Area 7 is recommended for treatment in 2019.

Area 8 was not treated in 2018, but CLP was observed here during the 2018 CLP survey and was again observed during the 2019 CLP survey. CLP in area 8 is in depths between 12 and 16 ft. of water. CLP is not expected to reach the surface here and should not become a navigational issue. Treatment of a site this small and in deep water is not likely to be successful and is not recommended for treatment in 2019.

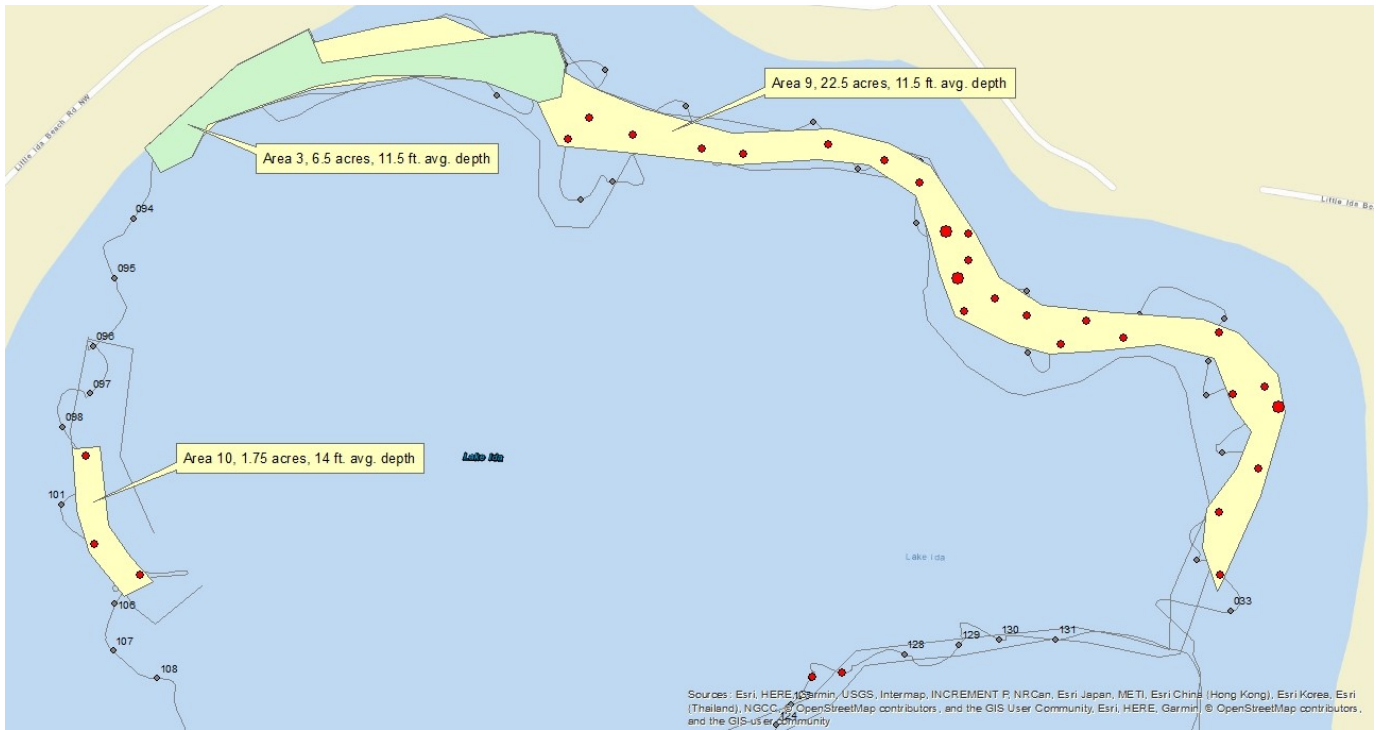
Area 3 was treated in 2018. CLP was observed here during the 2019 survey, and extended eastward into Area 9. CLP density within this area was generally light, and was found in deeper depths between 10 and 14 feet of water. Treatments in long, narrow sites in deeper water can be challenging to get good control.

Light growth of CLP was found throughout area 9 in depths between 10 and 14 feet of water. Treatments in long, narrow sites in deeper water can be challenging to get good control, however, treatment may be warranted due to the long length of the site. We recommend the lake association discuss their goals for treatment in this area, and if you want to treat the whole site, part of the site or just not treat this area.

Area 10 is a small area, with light growth of CLP in deeper water. Treatment is unlikely to be successful, and is not recommended.
