Ida Lake
(Douglas County)
Curlyleaf Pondweed Survey
Post-Treatment Inspection & Delineation

Survey Date: June 27, 2018

Report Date: July 8, 2018

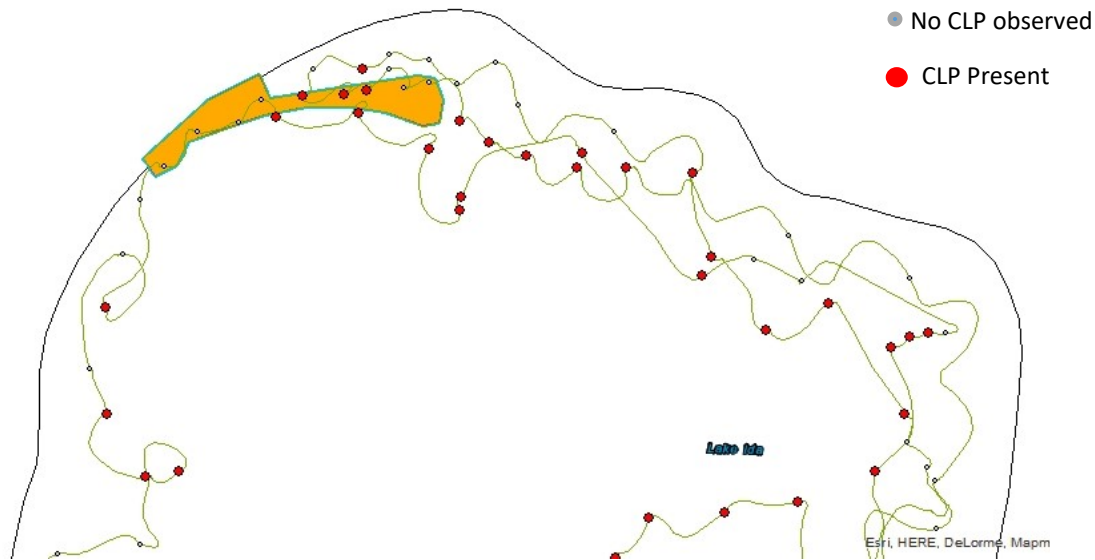
Figure 3. Post-Treatment Results of CLP Treatment Area 3

CLP was observed healthy and growing within half of treatment area 3, as well as throughout most of the bay in 10 to 18 feet of water. Without knowing pre-treatment CLP distribution, we cannot say how successful treatment was in this site.

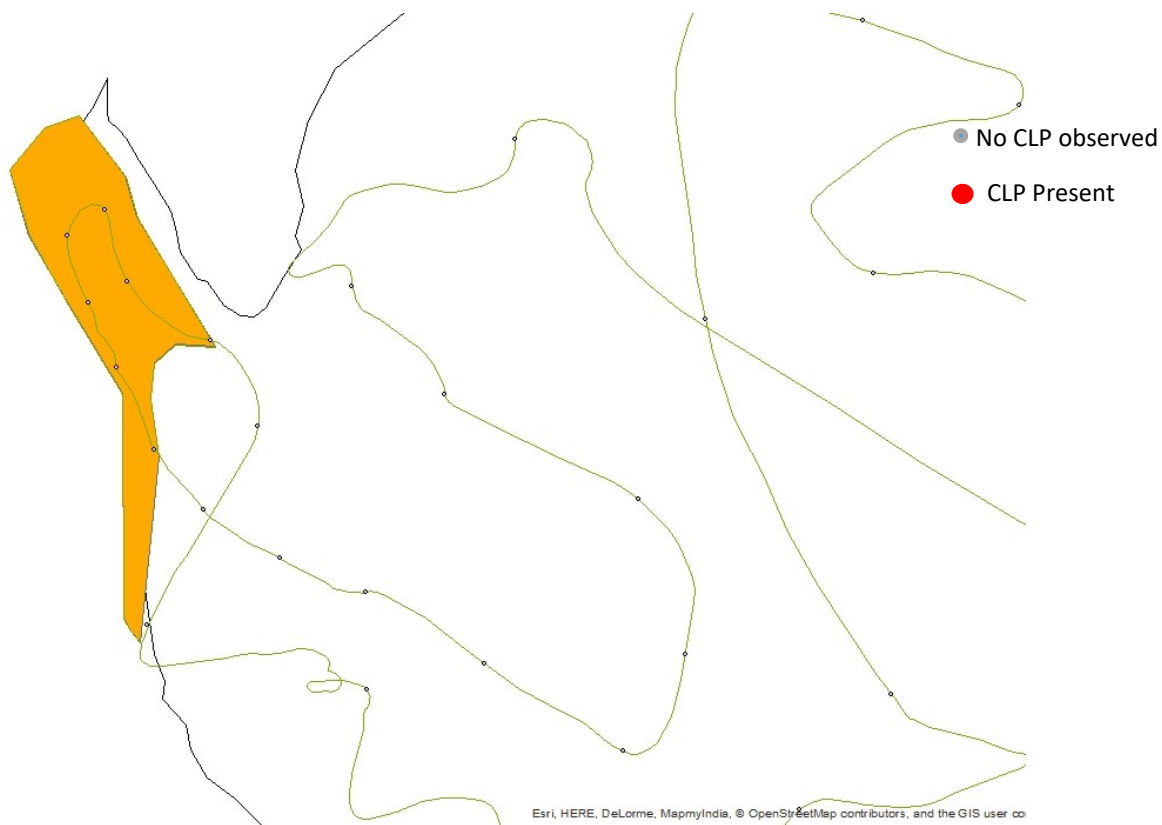
Figure 4. Post-Treatment Results of CLP Treatment Area 5

No CLP was observed within treatment area 5. Vegetation was scattered, with yellow water lilies, narrow leaf pondweed and floating leaf pondweed present. Assuming CLP was present prior to treatment, treatment at this site appeared to be successful.

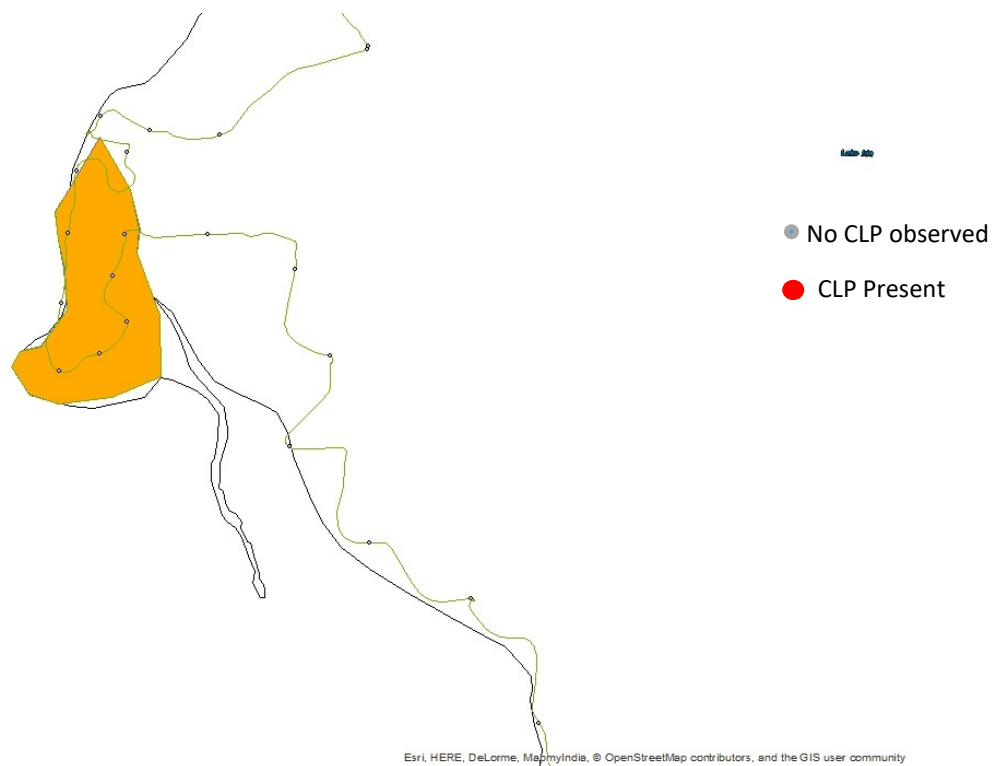
Figure 5. Post-Treatment Results of CLP Treatment Area 6

Some dead CLP stems were found within treatment area 6, pictures below. No healthy, actively growing CLP was observed. Overall, vegetation was scattered with Wild Celery and Yellow Water Lilies present. CLP treatment appeared to be successful.

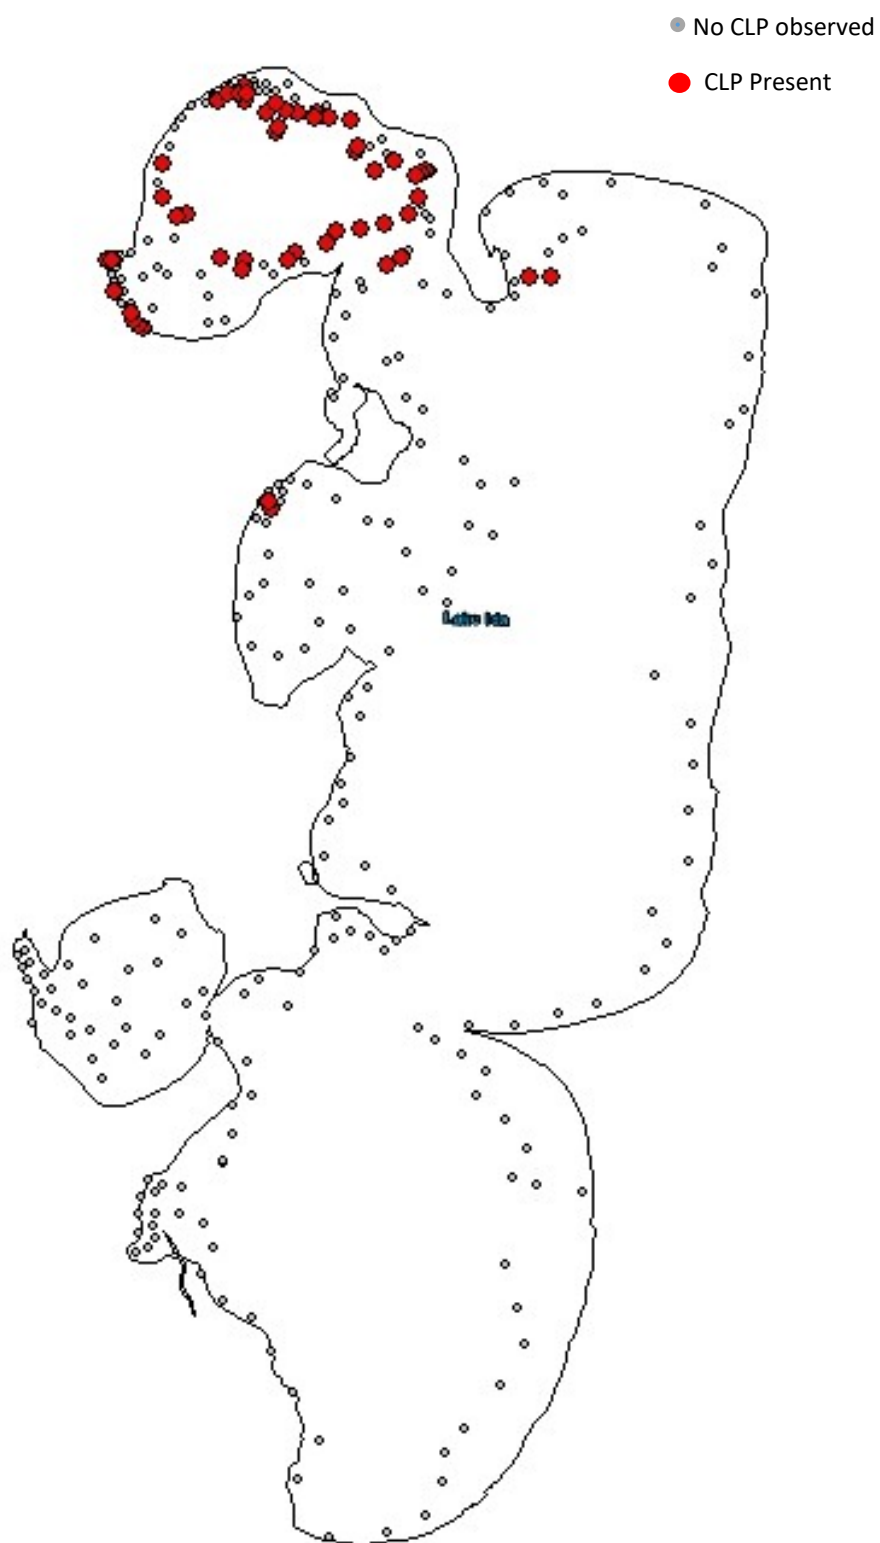
Figure 6. CLP presence/absence from June 27, 2018 survey

Red dots indicated CLP observed

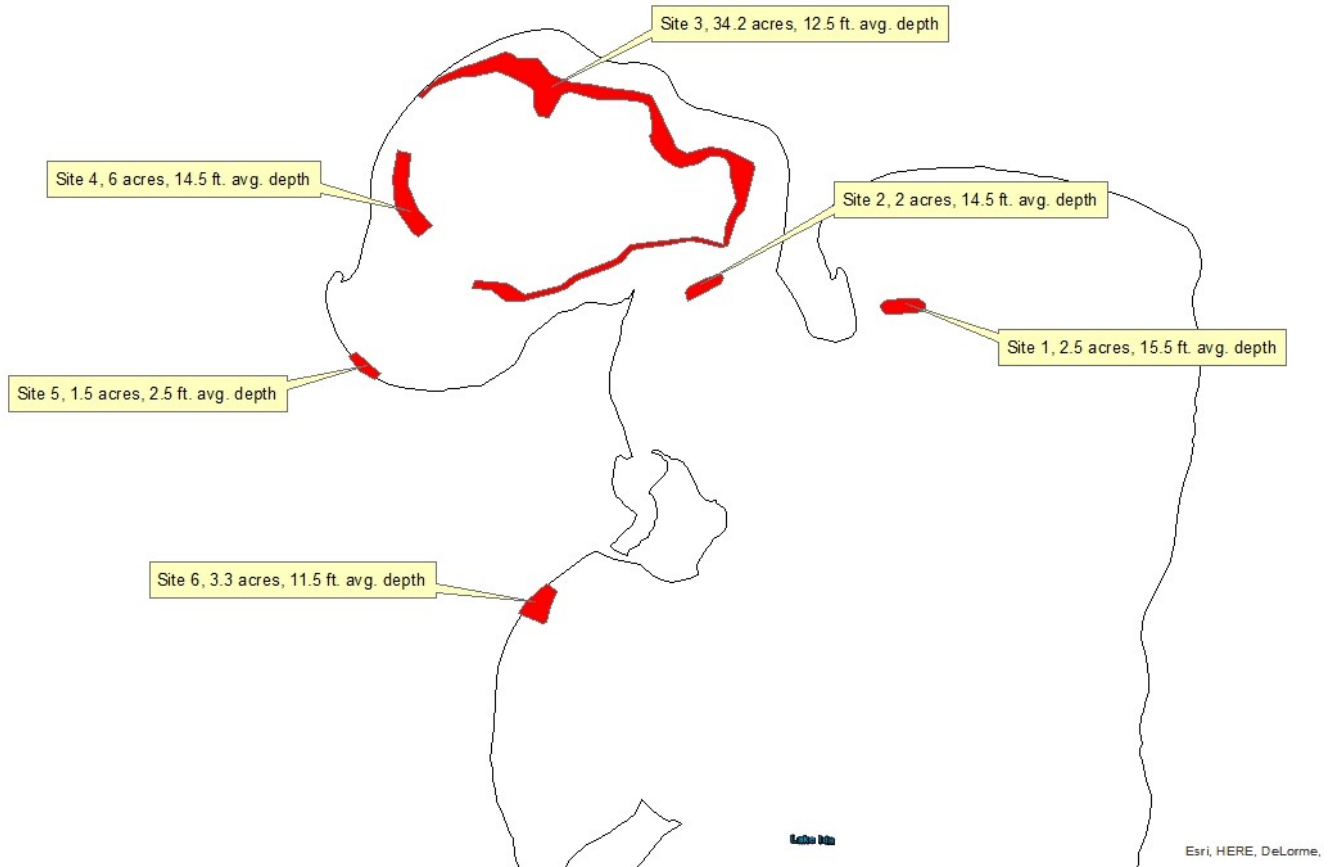
Figure 8. Potential CLP Management Areas

Curlyleaf Pondweed (CLP) was generally occupying deeper water, between 10 to 18 feet of water depth. CLP typically was about 6 to 8 feet tall in the deep water sites, so it was well below the surface of the water and was not providing any navigation concerns. Site 5 had scattered CLP occupying shallow water between 1 and 4 feet of water. Native plants were very abundant during the survey, and seem to be keeping CLP to deeper water depth locations. These native plant beds should be protected.
