Ida Lake

(Douglas County)

Curlyleaf Pondweed Delineation

Survey Date: May 26, 2019

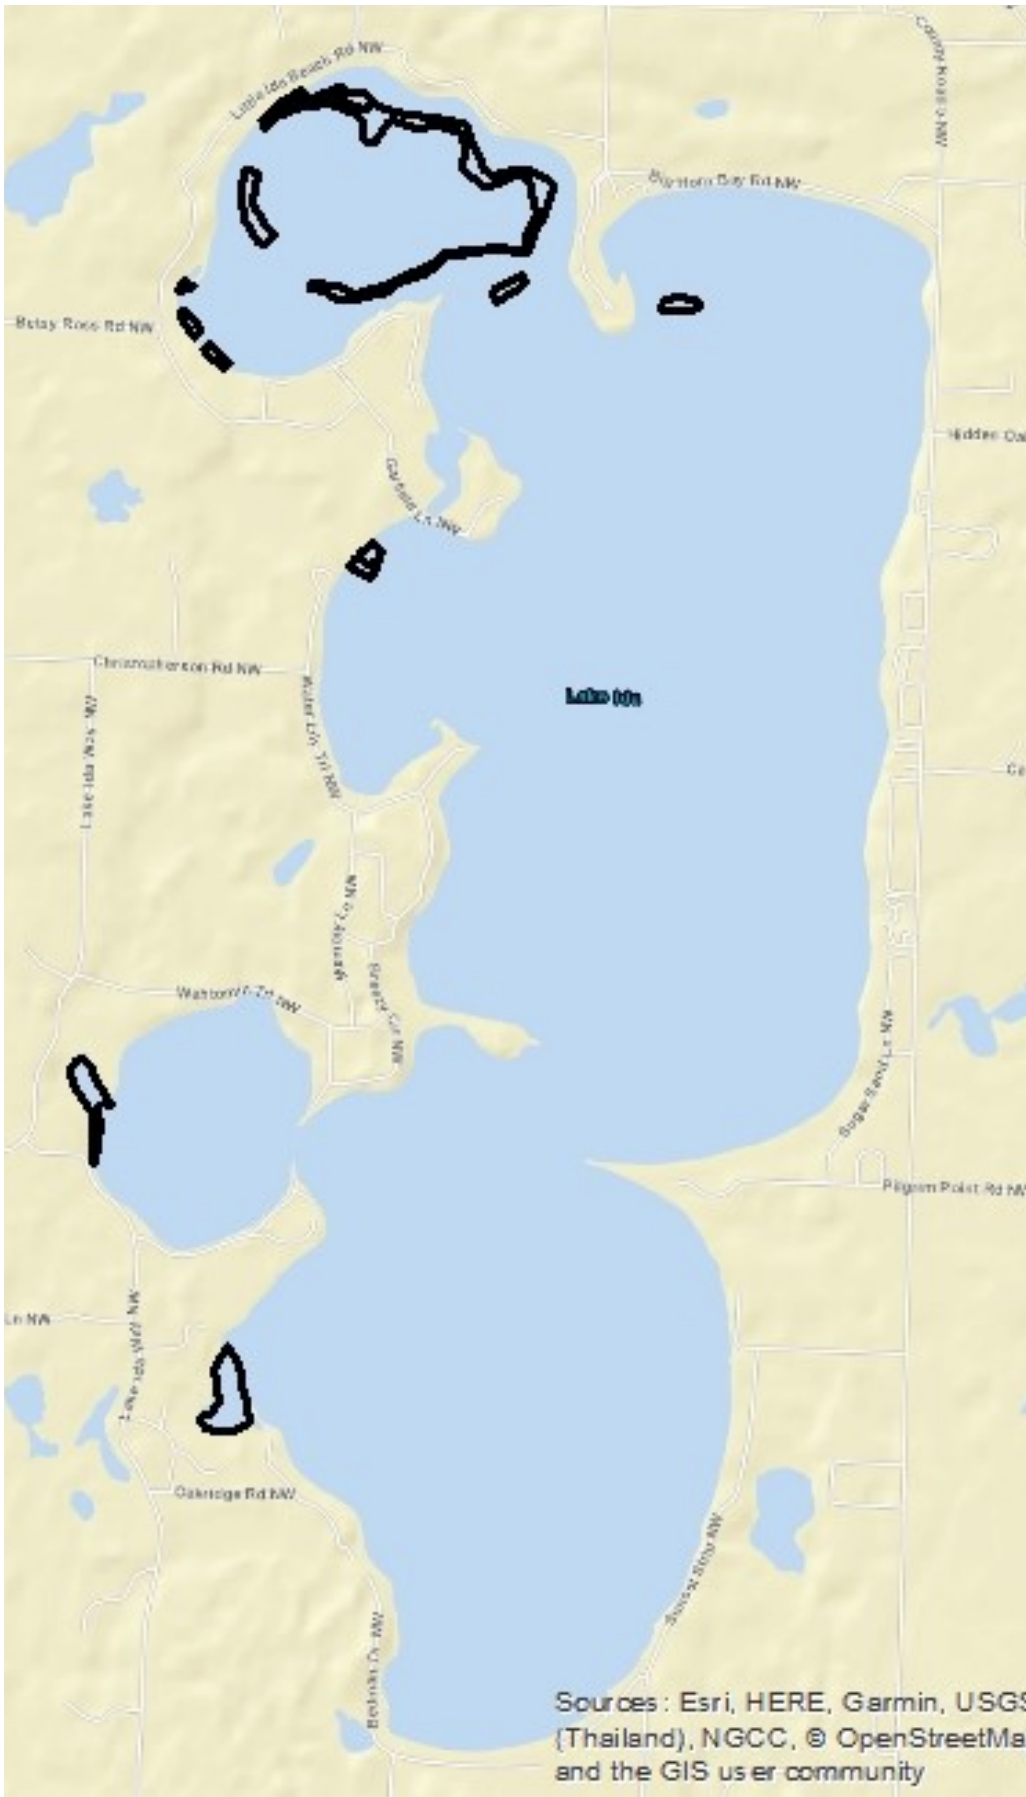
Figure 1. CLP Survey Search Areas

We maneuvered our boat in a meandering pattern within historical CLP areas (*figure 1*). Within each area, we used a combination of visual assessment, sonar unit and rake tosses to locate CLP. When CLP was found, we recorded the depth and estimated density of CLP at this point. Then additional areas were searched adjacent to that point to delineate the boundaries of the CLP bed. All waypoints were uploaded to GIS software, and maps were created for the CLP beds and an average depth was determined for each CLP bed.

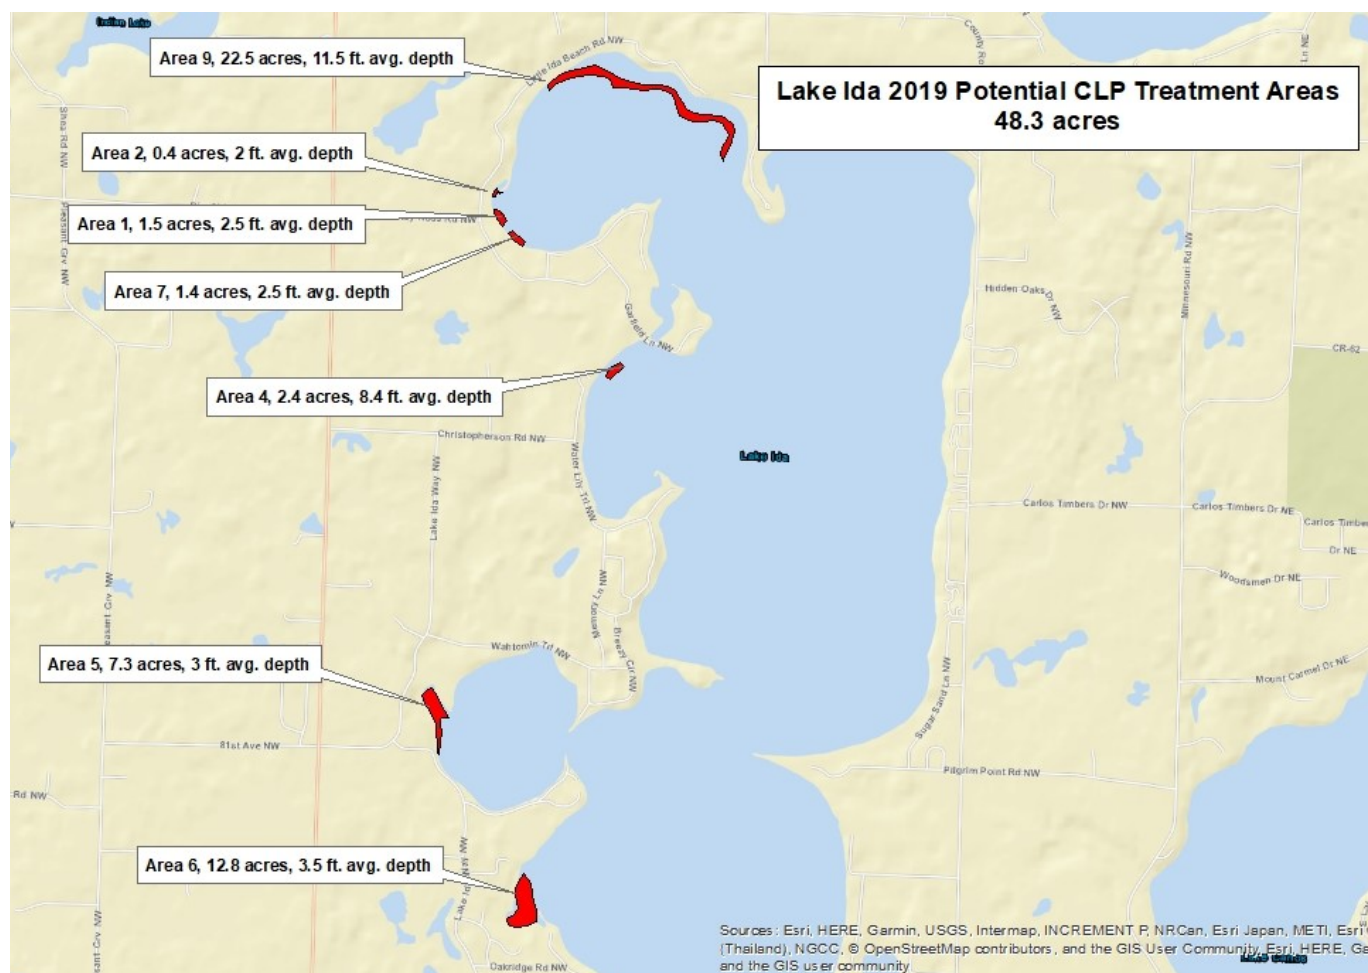
Figure 4. 2019 Potential CLP Treatment Areas

Area 3 was treated in 2018. CLP was observed here during the 2019 survey, and extended eastward into Area 9. CLP density within this area was generally light, and was found in deeper depths between 10 and 14 feet of water. Treatments in long, narrow sites in deeper water can be challenging to get good control.

Light growth of CLP was found throughout area 9 in depths between 10 and 14 feet of water. Treatments in long, narrow sites in deeper water can be challenging to get good control, however, treatment may be warranted due to the long length of the site. We recommend the lake association discuss their goals for treatment in this area, and if you want to treat the whole site, part of the site or just not treat this area.

Area 10 is a small area, with light growth of CLP in deeper water. Treatment is unlikely to be successful, and is not recommended.

CLP was abundant within treatment area 6 and is recommended for treatment in 2019.

CLP was found throughout treatment area 5 and is recommended for treatment in 2019.

CLP was found near treatment area 4 from 2018, however, we adjusted the site to better fit the distribution of CLP at this location. This site is recommended for treatment in 2019.

CLP was observed in Areas 1 and 2, and are both recommended for treatment in 2019.

Area 7 was not treated in 2018, but CLP was observed here during the 2018 CLP survey and was again observed during the 2019 CLP survey. Area 7 is recommended for treatment in 2019.

Area 8 was not treated in 2018, but CLP was observed here during the 2018 CLP survey and was again observed during the 2019 CLP survey. CLP in area 8 is in depths between 12 and 16 ft. of water. CLP is not expected to reach the surface here and should not become a navigational issue. Treatment of a site this small and in deep water is not likely to be successful and is not recommended for treatment in 2019.
