Ida Lake
(Douglas County)
Curlyleaf Pondweed Survey
Post-Treatment Inspection & Delineation

Survey Date: June 27, 2018

Report Date: July 8, 2018

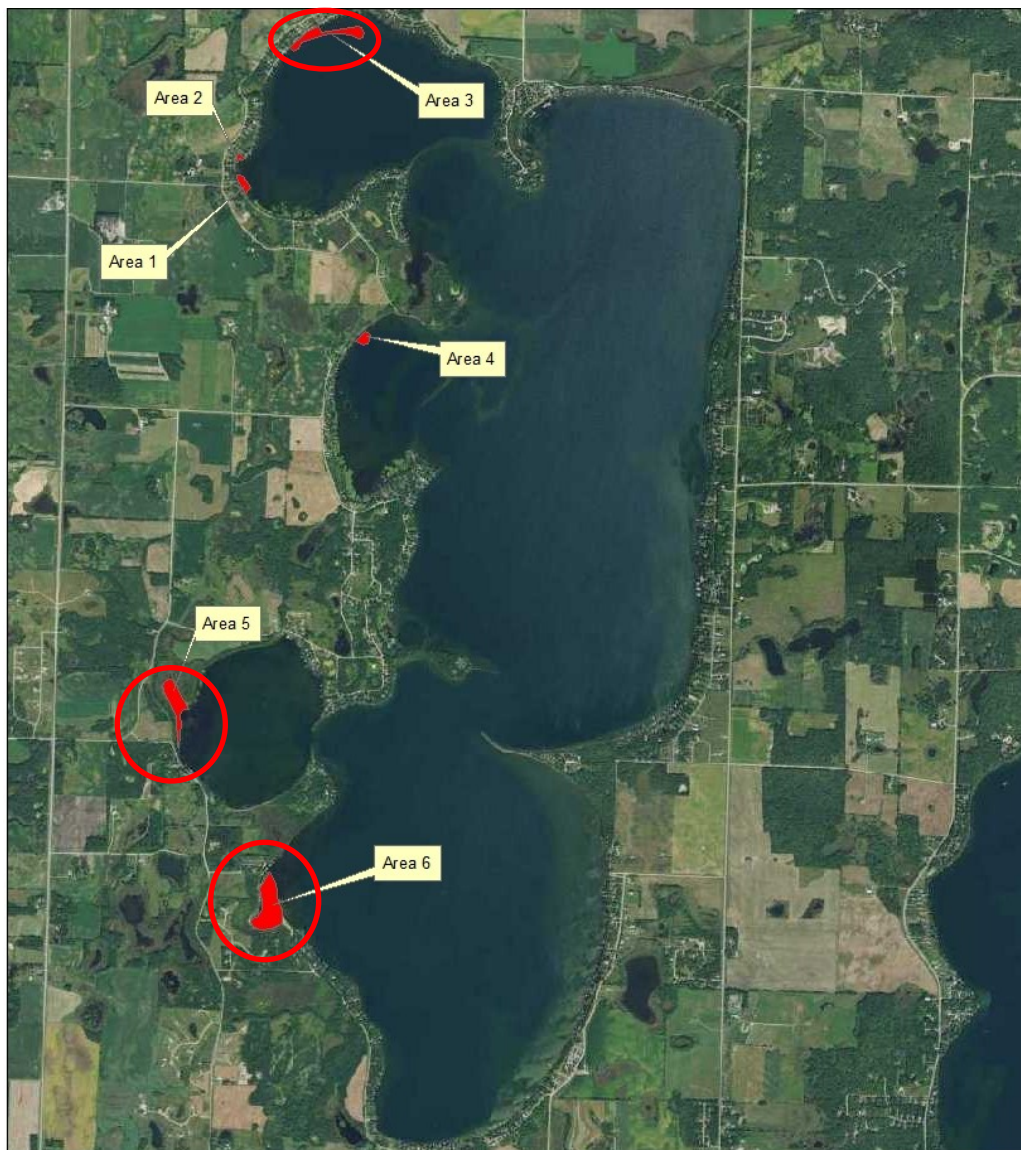
Figure 2. DNR Permitted Areas For Treatment

Without knowing pre-treatment conditions, the post-treatment evaluation assesses CLP distribution just over 4 weeks after the treatment occurred. Overall, native plant abundance was high and CLP seemed pretty well controlled within the treatment areas.

(Areas circled were actually treated)

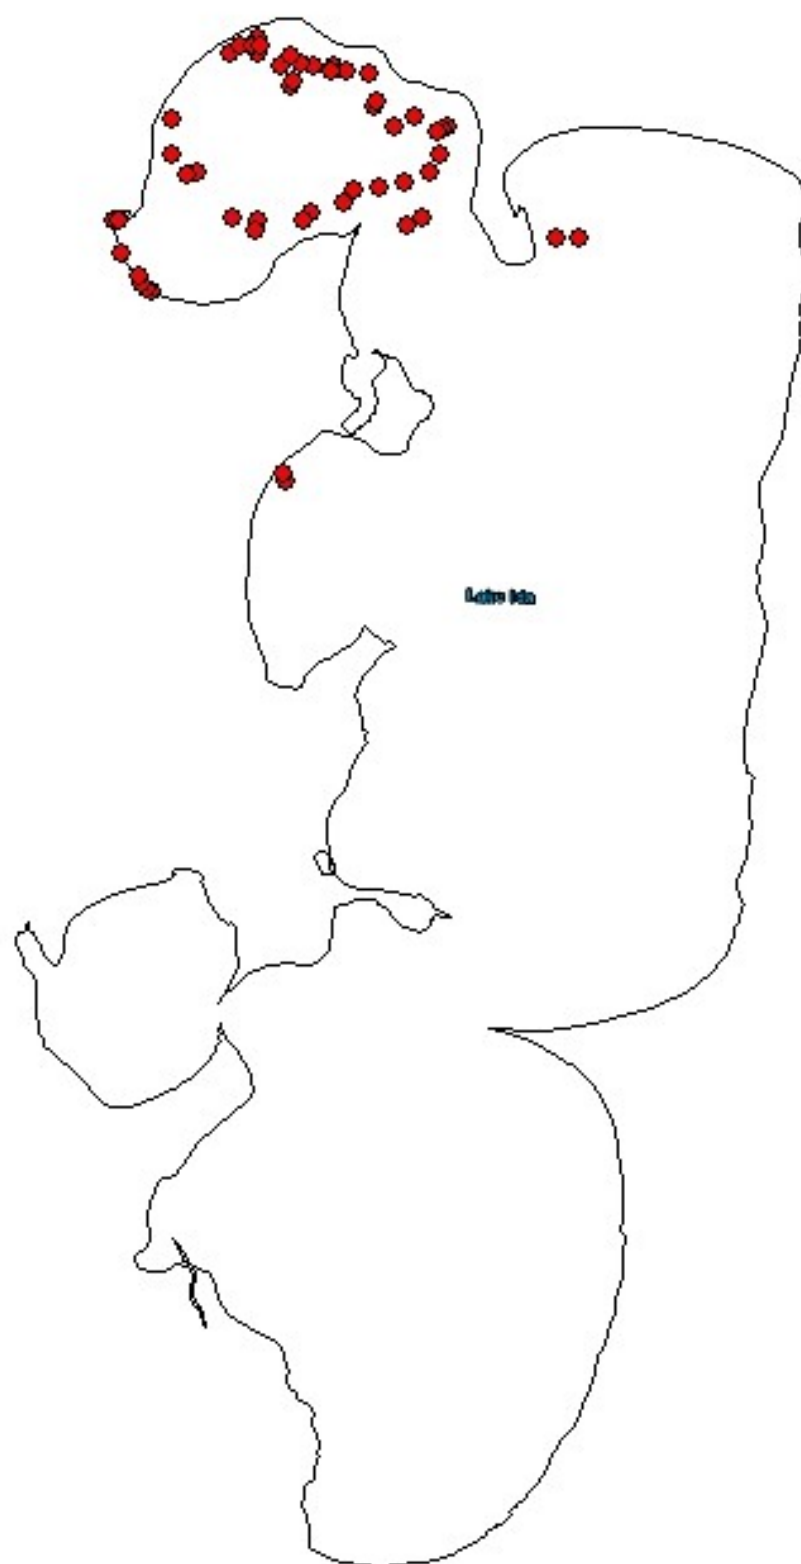
Figure 7. CLP Distribution

Curlyleaf Pondweed (CLP) was generally occupying deeper water, between 10 to 18 feet of water depth. CLP typically was about 6 to 8 feet tall in the deep water sites, so it was well below the surface of the water and was not providing any navigation concerns. Site 5 had scattered CLP occupying shallow water between 1 and 4 feet of water. Native plants were very abundant during the survey, and seem to be keeping CLP to deeper water depth locations. These native plant beds should be protected.
